STS-111
FLIGHT READINESS REVIEW

May 16, 2002

Ground Operations

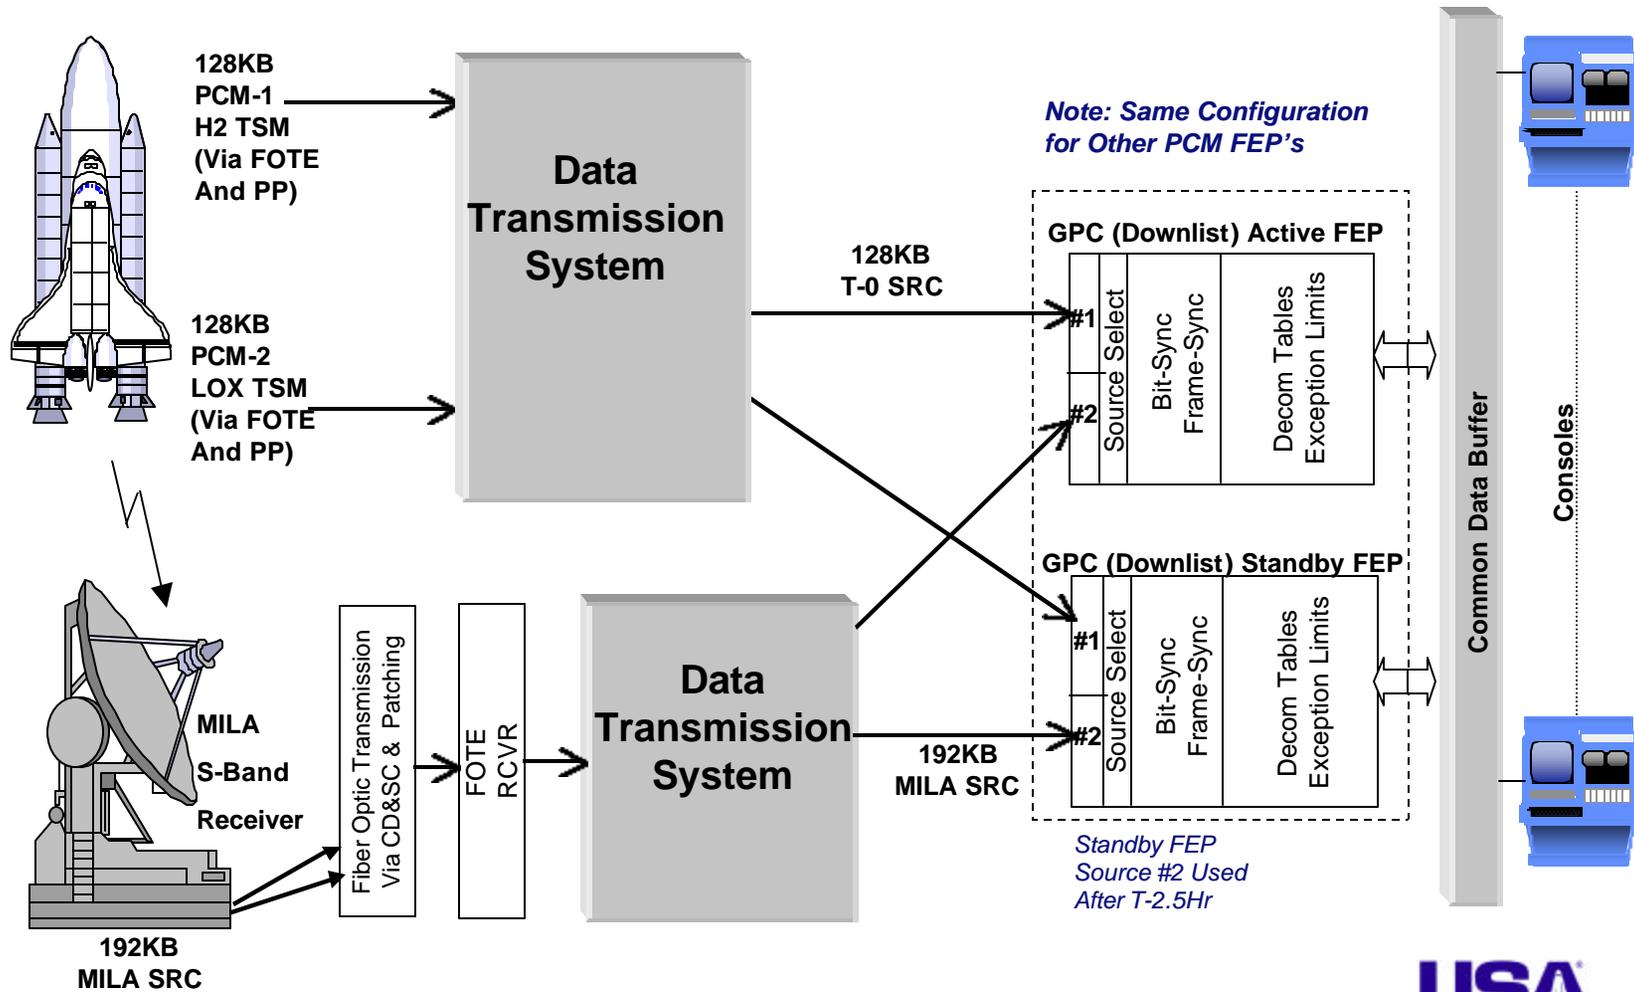
SIMPLIFIED PCM RF/HARDLINE DATA PATHS

- Observation
 - RF data interruption caused 3 standby Front End Processors (FEP) (OI, GPC, and Payload) to experience synchronization errors
 - Occurred during STS-110 Launch at T-7 minutes 3 sec
 - 2 of the 3 standby FEP's placed into NOGO as result of three consecutive synchronization errors
 - Active FEP's utilize hard line
 - T-0 connection to LPS FEP's
- Concerns
 - Loss of RF FEP integrity for command and control capability

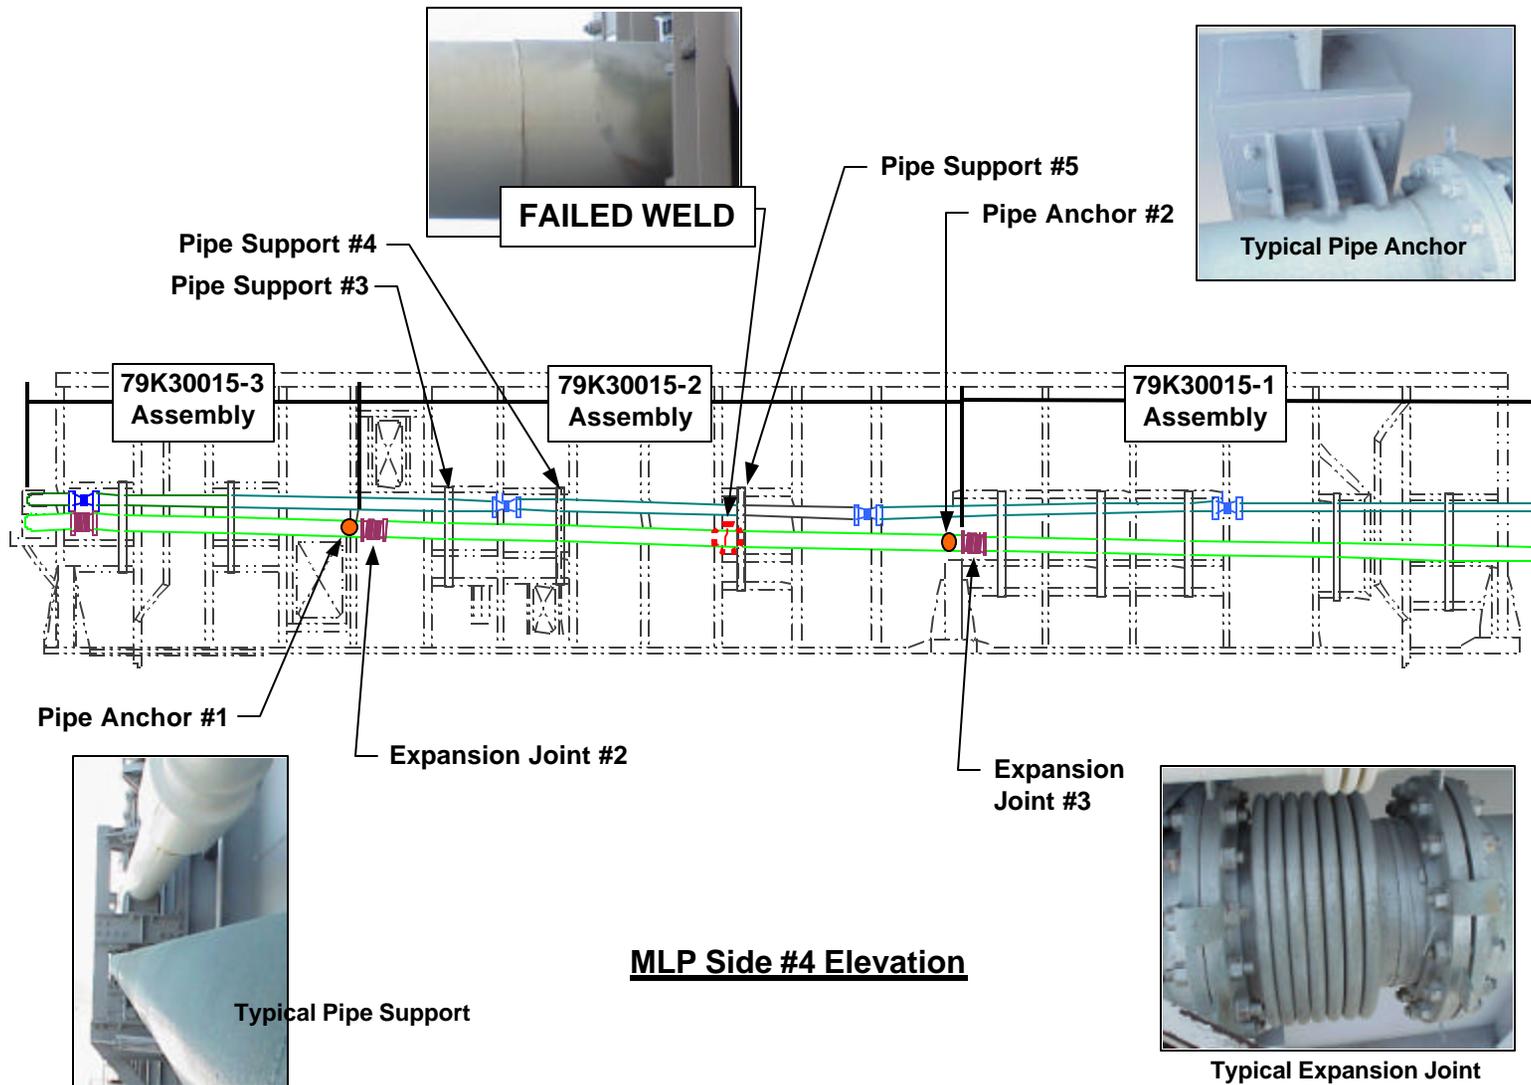
WELD CRACK ORIENTATION DIAGRAM

- Repaired clamshell and cracked weld removed for lab analysis
 - Lab's preliminary results and conclusions
 - Line failed in tensile overloading originating at bottom of weld

- Failure likely result of a single overload event
 - No evidence of fatigue or stress corrosion
 - Improper filler metal (4043) used to weld aluminum alloy (5083) – Very poor weld

- Excessive amounts Magnesium Silicide (Mg_2Si) in weld structure
 - Decreasing ductility and increasing crack sensitivity
 - Significant areas of incomplete penetration, excessive melt-thru, porosity and lack of fusion were observed

- Tests of intact failed weld section (3 specimens) showed ultimate tensile stresses of 31.7 ksi, 21.7 ksi and 8.9 ksi (Proper welded connection 40 – 45 ksi ultimate)

- MLP-3 Actions Taken (STS-110 Post Launch) (Cont'd)
 - Fracture Analysis
 - Fracture mechanics is not valid for these welds
 - Weld properties not known for incorrect filler material
 - Flaws exceed the size boundaries for the analysis
 - Most Probable Cause For Weld Failure
 - Launch-Induced loads propagating cracks and/or developing internal stresses
 - Incorrect filler metal 4043 used on 5083 aluminum
 - Very poor weld quality – type and number of flaws
 - Final failure resulting from the lower thermal stressing during tanking

- Certification of MLP1 H2 Vent Lines for Launch
 - Visual inspection of H2 vent lines completed
 - No discrepancies with vent line and structural supports
 - All 60 welds passed helium detection leak checks
 - Ultrasonic imaging completed on 36 welds of the 5083 configuration
 - Screening Criteria for H2 vent line welds complete
 - Identified 5 welds having a 3 sigma stress of 9 ksi or greater (minimum failure value of tensile test coupons)
 - Chemically etch and determine 2 of the 5 welds used the improper 4043 filler material on the 5083 pipe
 - Stress loads for the 2 welds with 4043 filler material are being re-evaluated to account for the structural supports unique to MLP-1
 - A leak check and cold shock will be performed on any new reinforced weld

- Tanking Rationale
 - Number and type of flaws are acceptable based on :
 - Predicted (3 sigma) stresses below 9 ksi for incorrect filler metal
 - Use of correct filler metal
 - Welds that exceed 9 ksi and have incorrect filler metal will be reinforced
 - Double Wall Line is only used on external vent lines
 - Line can be secured by closing upstream valve
 - Standard Emergency Safing Procedures
 - All Vent Lines have purge capabilities for inerting/safing
 - Dedicated console operator performs continuous OTV scans during loading (facilitate immediate safing)
 - Line/supports inspected annually and proof tested to 18 psi before use
 - Risk Assessment
 - No risk to Flight and Crew's safety
-

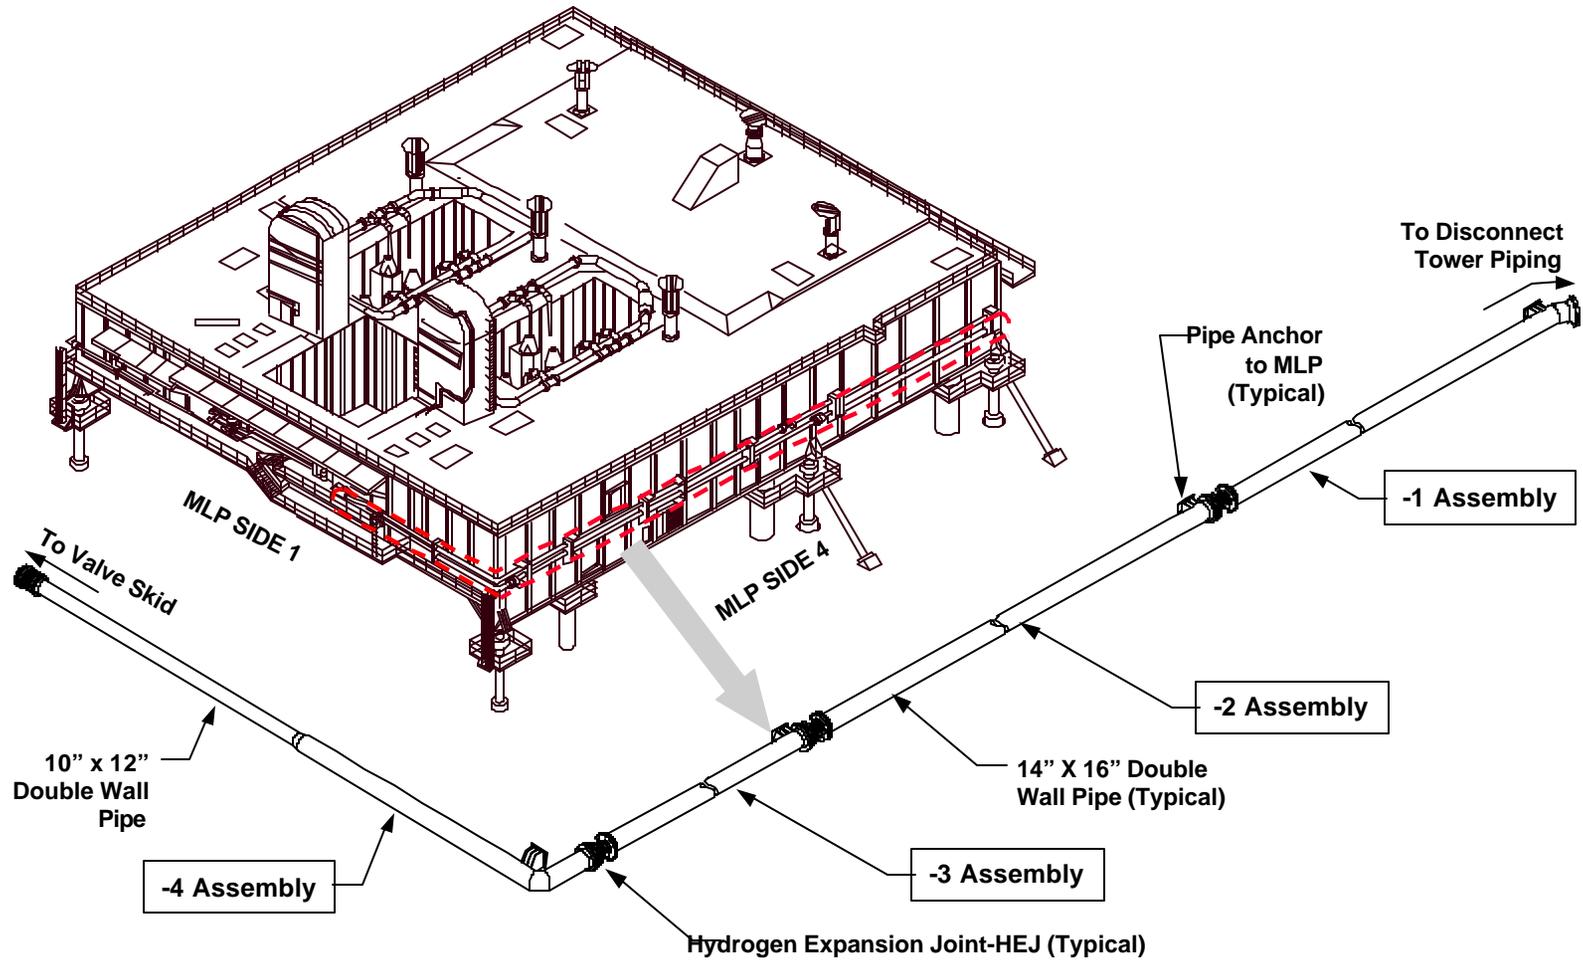
MLP H2 DOUBLE WALL VENT LINE ASSEMBLIES

- Discussion
 - MLP Hydrogen vent line characteristics
 - Double wall aluminum piping
 - Slotted spacers between Inner and Outer line provide a Hydrogen gas blanket for thermal insulation
 - Cryogenic fill and internal MLP lines are Stainless steel vacuum jacketed
 - MLP1 is supporting STS-111 launch operations
 - All three MLP's utilize Apollo era components to fabricate H2 vent lines
 - Approximately twice the cryogenic loads than MLP3
 - MLP3 had 46 cryo loads and 26 launches
 - MLP1 has 84 cryo loads and 44 launches

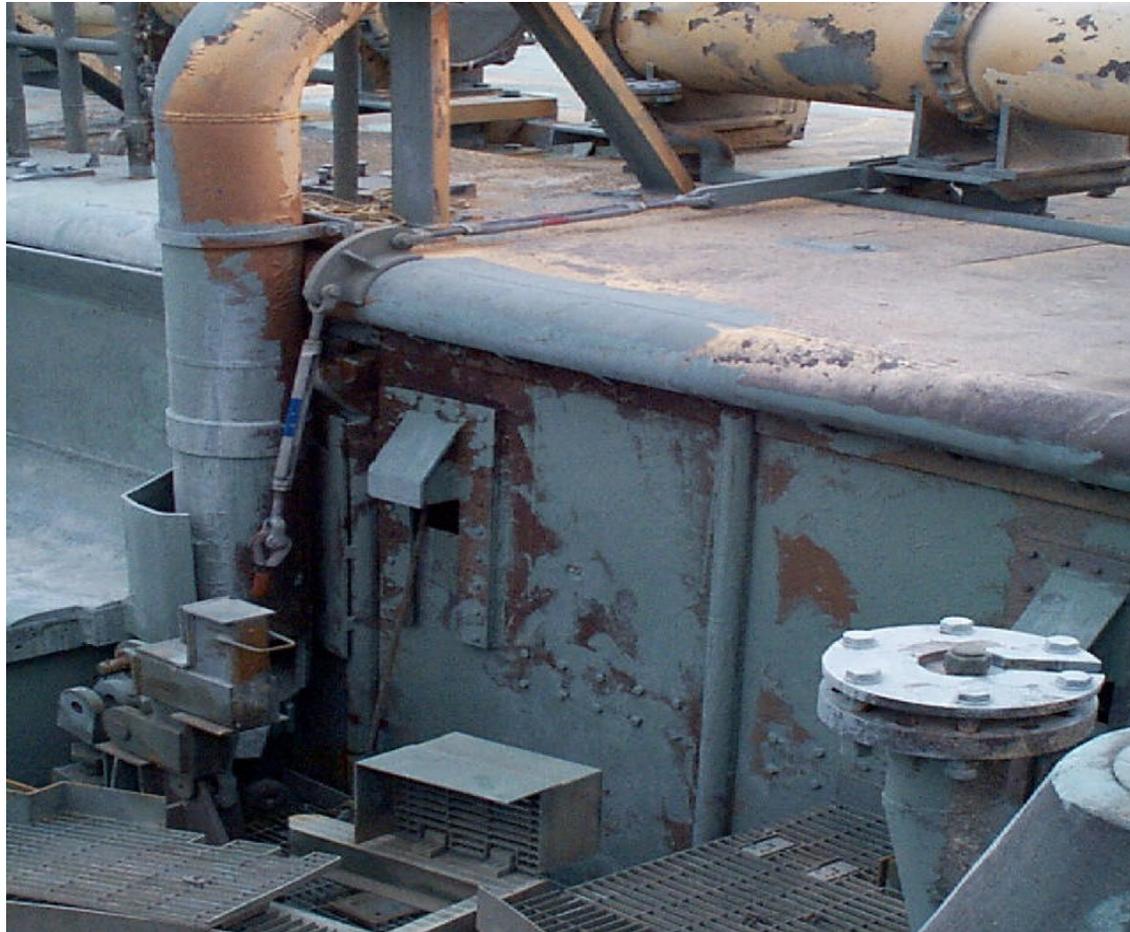
ENGINEERING TOPIC
MLP HEAT SHIELD RETAINER BARS
(CONT'D)

- Actions Taken
 - STS-110 MLP-3 Post launch inspections
 - Retainer bar that separated from MLP3
 - Top 2 roll pins were missing
 - Never installed when built (no hole witness marks)
 - Corrosion observed on remaining 4 roll pins
 - Corroded from inside to outside
 - Enhanced Heat Shield Roll pin Inspections for STS-111
 - Remove screed covering roll pins removed
 - Verify no obstructions (corrosion, etc)
 - Utilize dental pic along ID of roll pins

- Flight Rationale
 - Enhanced inspections verify roll bar pin installation integrity
